MUSCULOSKELETAL DISCOMFORT RISK FACTORS FOR MEDICAL RADIATION TECHNOLOGISTS PERFORMING BREAST SCREENING

Marion Edwin and Sue Alexander
Optimise Ltd, PO Box 390, Motueka. marion@optimiseltd.co.nz

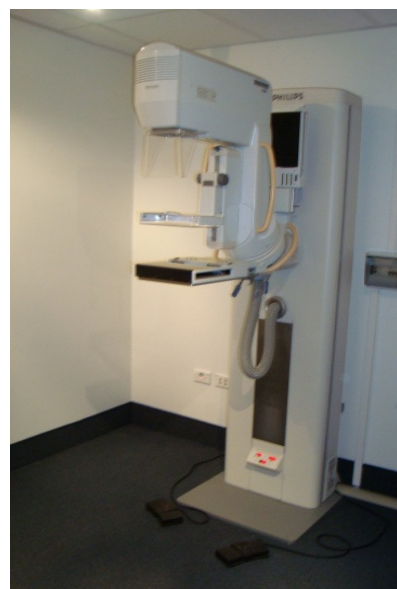
Figure 1. Mammography unit.

The mammography unit is free standing. The woman stands (or sits) up to it, and must move body and arms into various positions in order for their breast to be moved into the correct position on the 'bucky', for high quality breast images to be taken. The top of the machine is swung into different positions to facilitate gaining the correct angle for breast images. Once the breast is in the correct position, the pressure plate is lowered and the image taken. Plates are changed for each image, and the x-ray films developed.

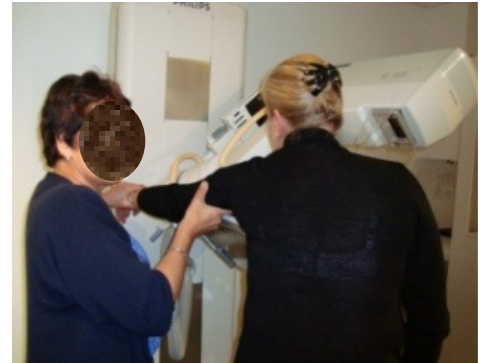
Figure 2. MRT positioning the arm and body for breast screening.

Observation of their work methods and analysis using REBA showed a range of awkward stooping, squatting, and bending actions, and many arm and

shoulder reaching actions. MRTs use their hands firmly but gently to position breast tissue – grasping, pulling, lifting, smoothing – often with their shoulders elevated and abducted. Some of these actions are forced by the nature of the task but others are learned methods that can be altered. The work methods taught in training appeared to require updating to include safe methods for working with tall and large women particularly.

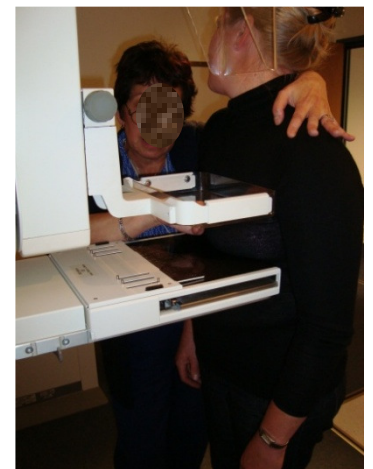
Figure 3. Simulation of MRT positioning a breast.
